# TROUBLE TRACER – LININGS

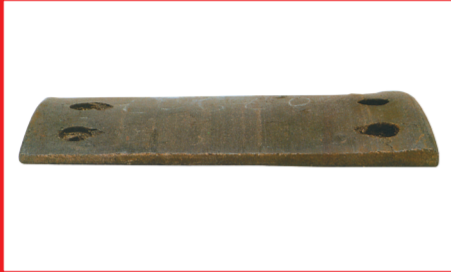
**LINING SURFACE TAPERED**

**MAIN REASONS**

- Brake shoes misaligned with the brake drum
- Distorted brake shoe or brake drum turned on taper

**POSSIBLE EFFECTS**

- The linings may lock on to the drum when braking from high speeds
- Vehicle pull and excessive brake noise may occur

**SOLUTION** Replace or grind/machine drum. Replace brake shoe anchor pins or parts that locate brake shoes

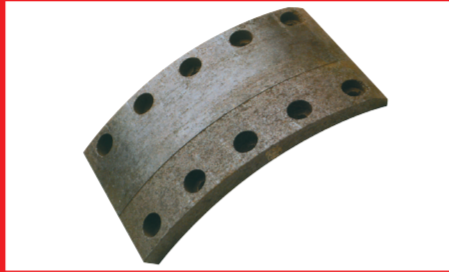
**STEPS IN THE LINING SURFACE**

**MAIN REASONS**

- There may be a step in the brake drum surface
- General drum wear

**POSSIBLE EFFECTS**

- Rapid lining wear
- If the wear pattern differs across the axle, vehicle pull and excessive noise can result

**SOLUTION** Grind/Machine drum surface or renew (a drum grind may incur oversize lining fitment)

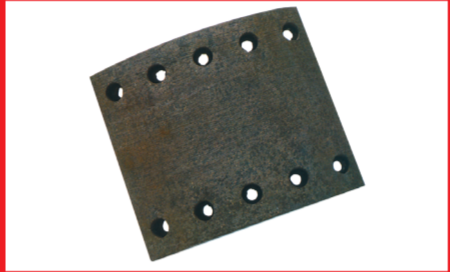
**CIRCUMFERENTIAL GROOVES**

**MAIN REASONS**

- Poor drum condition
- Improper preparation with a wire brush, shoe grinder or similar

**POSSIBLE EFFECTS**

- Vehicle pull may occur if there is a different wear pattern on the opposite axle end
- Insufficient deceleration and excessive noise

**SOLUTION** Replace linings and grind or replace drum as appropriate

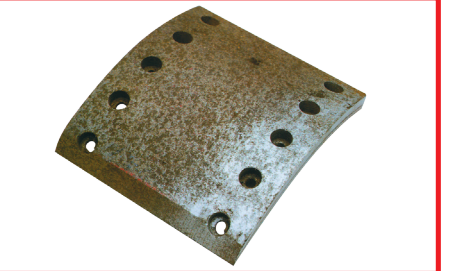
**DIRT ON THE LINING SURFACE**

**MAIN REASONS**

- Dirt particles in the brake
- Poor brake maintenance (insufficient cleaning)

**POSSIBLE EFFECTS**

- High lining and drum wear
- Poor deceleration
- Vehicle pull and excessive brake noise may occur

**SOLUTION** If heavy contamination, replace linings and ensure contamination-free relining operation

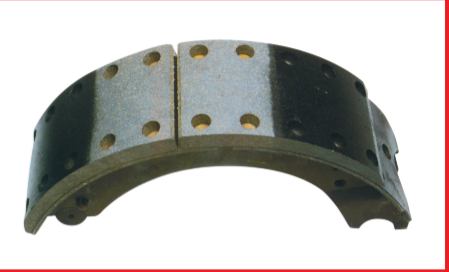
**POOR BEDDING-IN 1**

**MAIN REASONS**

- Lining radius is larger than actual drum diameter
- Bedding-in period for the lining was too short

**POSSIBLE EFFECTS**

- Vehicle pull and excessive brake noise may occur
- Low deceleration

**SOLUTION** Replace linings and ensure the correct lining radius to drum diameter is selected, or extend bedding-in period

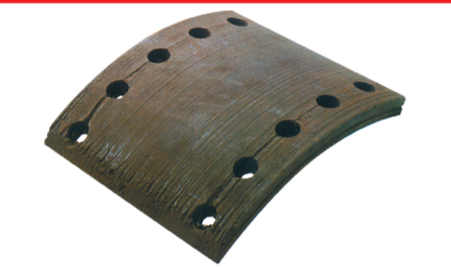
**DEEP IRREGULAR CIRCUMFERENTIAL GROOVES**

**MAIN REASONS**

- Large particles loose in the brake
- Very poor drum condition and maintenance

**POSSIBLE EFFECTS**

- Very high lining and drum wear
- Squeal

**SOLUTION** Avoid contamination. Replace linings and grind or replace drum as appropriate.

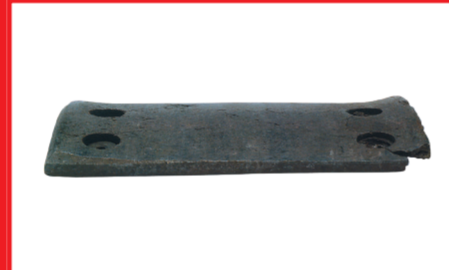
**UNEVEN LINING SURFACE**

**MAIN REASONS**

- Wrongly adjusted or worn axle bearings

**POSSIBLE EFFECTS**

- Very high lining and drum wear
- Squeal

**SOLUTION** Replace linings, replace wheel bearing and replace or grind drum as appropriate

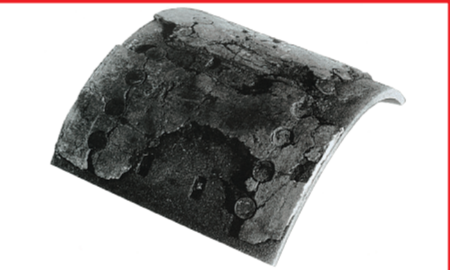
**LARGE FRACTURES IN LINING SURFACE**

**MAIN REASONS**

- Faults in brake mechanism
- Sticking brake shoes (weak return springs)
- Excessive use of brakes at high speed
- Overloaded vehicle
- Too large air chambers

**POSSIBLE EFFECTS**

- High lining wear
- Vehicle pull and excessive brake noise
- Disintegration of lining
- Low deceleration

**SOLUTION** Replace linings, avoid overworking brakes and ensure brake components are correct and are in good condition

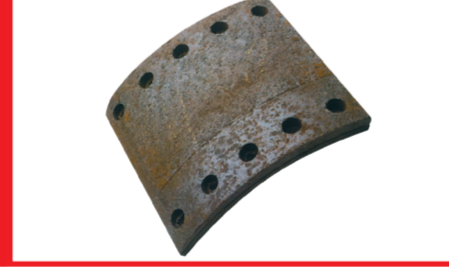
**SCARRED LINING SURFACE**

**MAIN REASONS**

- Poor drum condition, e.g. heat crazing

**POSSIBLE EFFECTS**

- Rapid lining wear
- If linings not 100% bedded-in, low brake efficiency can result

**SOLUTION** Replace linings and avoid overheating brakes

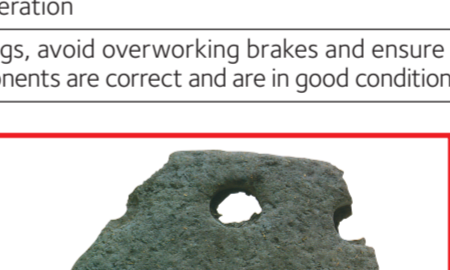
**BURNT LINING SURFACE**

**MAIN REASONS**

- Faults in brake mechanism
- Sticking brake shoes (weak return springs)
- Excessive use of brakes from high speed
- Wrong brake cylinders/air chambers or levers
- Overloaded vehicle
- Incorrect brake proportioning between tractor/trailer units

**POSSIBLE EFFECTS**

- High lining wear
- Vehicle pull and excessive brake noise
- Deceleration too low

**SOLUTION** Replace linings, avoid overworking brakes and ensure brake components are correct and are in good condition

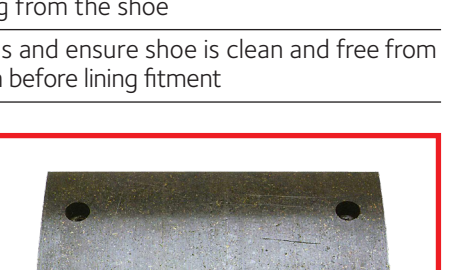
**SURFACE CRAZING**

**MAIN REASONS**

- Caused by excessive brake temperature, i.e. when brake is cold on motorway then having to perform a sudden stop i.e. off a slip road. Rapid temperature input does not allow for heat soak from material into brake system

**POSSIBLE EFFECTS**

- This condition has no effect on the integrity or performance of the lining
- Penetration of the crazing is usually no more than 1mm deep
- Wear through with normal brake use and has no effect on the lining

**SOLUTION** Avoid high-speed heavy duty braking from cold
