STEERING & SUSPENSION PARTS

TROUBLE TRACER CHART

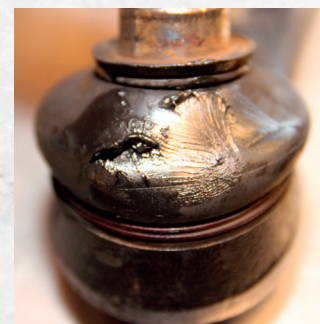
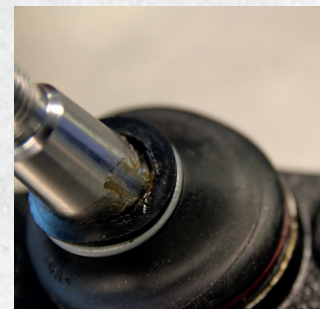
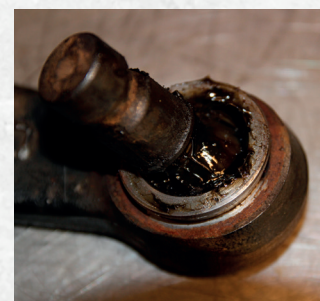
DUST BOOT SEALING ISSUE

Appearance:
Small cuts on rubber boot or obvious lack of sealing around ball pin, often evident through the appearance of grease.

Most probable causes:
– High speed projection of sharp element from the road
– Misuse of sharp tools during installation
– Poor sealing performance around ball pin
– Rubber boot defect

Effect:
Water intrusion causes reduced lubrication power as grease is progressive lost from the housing.
→ Excessive play in the ball pin, knocking noise.

How to fix it:
→ No repair possible. Part must be replaced.

Prevention:
– At installation, check dust boot for defects and ensure a secure retention of the boot around the housing and ball pin (Moog's advanced quality control is designed to eliminate these issues)
– When fitting, use correct tools and take care not to cut the boot
– Correctly fit fixing strips around the steering rack gaiters

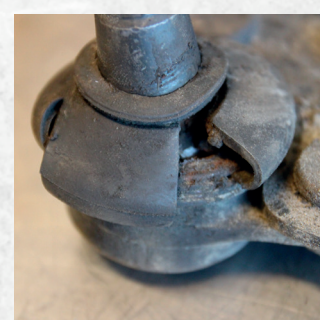
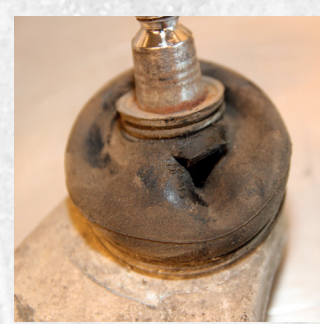
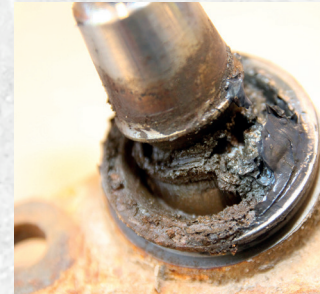
DUST BOOT DAMAGES

Appearance:
Large rip or split on the rubber boot, having a 'exploded' like appearance. Severe water/dust contamination can be observed inside the housing.

Most probable causes:
– Small cut that has enlarged over time
– Rubber boot turning with the ball pin during operation (repetitive twisting of the dust boot will eventually cause it to split)

Effect:
Grease becomes 'paste' like due to water and dust intrusion, quickly damaging ball pin plastic socket.
→ Excessive ball pin play and loud knocking noise.

How to fix it:
→ Play and knocking noise will quickly worsen, potentially to a safety-critical level. No repair possible. Part must be replaced as soon as possible.

Prevention:
– At installation, check dust boot for defects
– Ensure that the ball pin can freely rotate within its dust boot (Moog's advanced design follows OE specifications to avoid this issue)
– In the case of a link stabilizer, ensure that dust boot is not twisted after installation

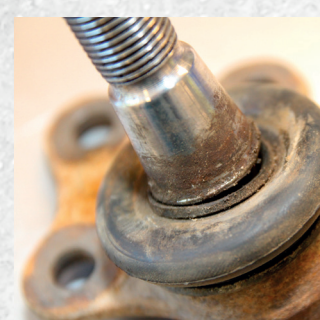
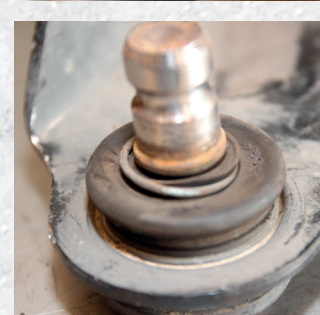
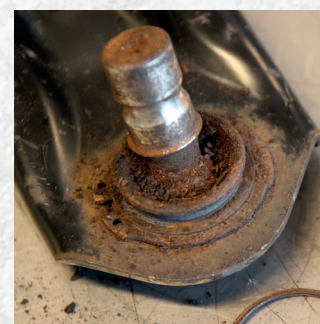
DUST BOOT INCORRECT POSITION

Appearance:
The dust boot top opening stands around ball pin neck, i.e. under the stopper usually present on lower area of a ball pin.

Most probable causes:
– The dust boot has unintentionally been pushed down too far the ball pin neck during installation

Effect:
– Whilst the dust boot may not look damaged, its incorrect position allows an open entry for contaminants such as water and dust
– Grease becomes 'paste' like due to water and dust intrusion, quickly damaging ball pin plastic socket
→ Excessive ball pin play and loud knocking noise.

How to fix it:
→ Play and knocking noise will quickly worsen, potentially to a safety-critical level. No repair possible. Part must be replaced as soon as possible.

Prevention:
Take care while introducing the ball pin within the wheel knuckle. The dust boot shouldn't be handled during this operation, it will naturally take its correct position when the part is fitted (Moog parts are designed for optimum sealing performance once inserted in the wheel knuckle)

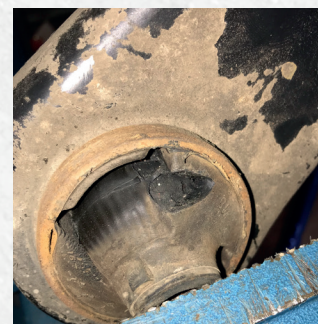
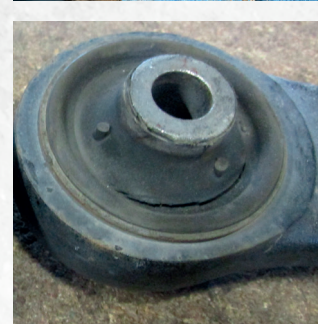
BUSHING RADIAL SPLIT

Appearance:
Rubber cracks on the radial direction of the bush, typically in the void area.

Most probable causes:
– Bush/void design issue
– Bush is defective or too rigid for the application
– Incorrect orientation of the bush during installation

Effect:
Regardless of size, the crack will progressively increase over time.
→ Abnormal vehicle behaviour. During braking and acceleration, forces are not reverberated at the right locations. In extreme cases the vehicle could be hard to control, risking driver safety.

How to fix it:
→ No repair possible. Bush or control arm must be replaced as soon as possible.

Prevention:
– At installation, check the bush is free of any defect (Moog's advanced quality control ensures that parts match OE specifications for every application)
– When fitting, take care to correctly orient the bush

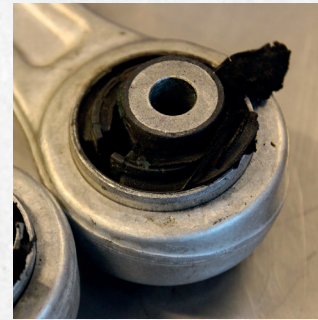
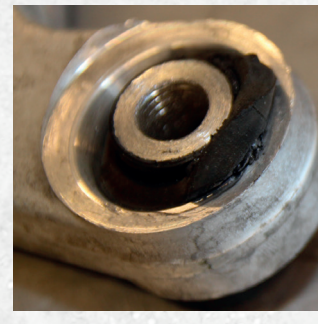
BUSHING AXIAL SPLIT

Appearance:
Bush rubber is split in axial direction, appearing as if 'over-twisted'.

Most probable causes:
– Bush is defective or too rigid for the application
– Control arm has been fully tightened on the vehicle sub-frame without the wheels being on the ground, causing abnormal pre-stress once the vehicle recovers its neutral position

Effect:
This will quickly lead to damage of all rubber around the bush inner tube, resulting in a knocking noise.
→ Abnormal vehicle behaviour. During braking and acceleration, forces are not reverberated at the right locations. In extreme cases the vehicle could be hard to control, risking driver safety.

How to fix it:
→ No repair possible. Bush or control arm must be replaced as soon as possible.

Prevention:
– At installation, check the bush is free of any defect (Moog's advanced quality control ensures that parts match OE specifications for every application)
– Limit first torque to a value allowing the bush inner tube to rotate within its seat while the vehicle is progressively recovering its neutral position. Apply the final torque value once the vehicle is grounded

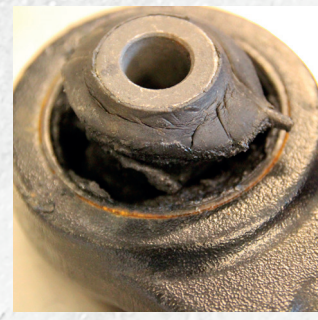
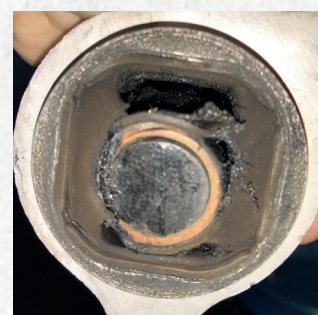
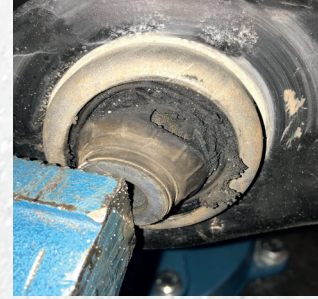
BUSHING STICKY RUBBER

Appearance:
Rubber is deformed and sticky.

Most probable causes:
– Contamination from contact with oil or other chemicals has altered the properties of the rubber causing it to become pasty and sticky
– Non-conform curing parameter during rubber vulcanization

Effect:
The bush rubber will progressively lose its elasticity and rigidity, altering its damping features.
→ Abnormal vehicle behaviour during braking and acceleration. In extreme cases the vehicle could be hard to control, risking driver safety.

How to fix it:
→ Bush or control arm must be replaced as soon as possible.

Prevention:
– Ensure bush conformity prior to fitting. The rubber must not feel sticky. (Moog has strict quality control measures for the vulcanization process to avoid any curing issues)
– Ensure the parts are stored away from any chemicals
– Check and repair any fluid leakage which could contaminate the bushes

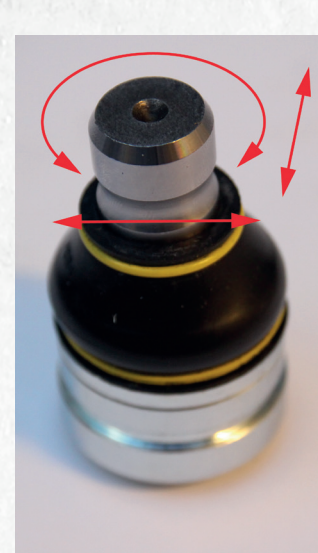
LOOSE BALL PIN

Appearance:
Whilst no visible trace of damage and contaminant intrusion on housing area is evident, by hand the ball pin is very easy to move (rotation torque < 1-2Nm) or a small clearance can be felt.

Most probable causes:
– Product defect
– Internal damage caused by hard driving or impact, especially at roundabouts (kerb, pothole, speed hump etc.)
– Normal wear in case of extensive service life

Effect:
The ball pin will loosen more over time.
→ Excessive play in the ball pin, knocking noise.

How to fix it:
→ No repair possible. Part must be replaced.

Prevention:
– Check, by hand for the correct articulation of the ball pin within its housing (Moog's advanced quality control only validates each assembly when the correct torque is achieved)
– Avoid hard driving and impacts
– Fit high quality, durable parts. Moog design features ensure best service life

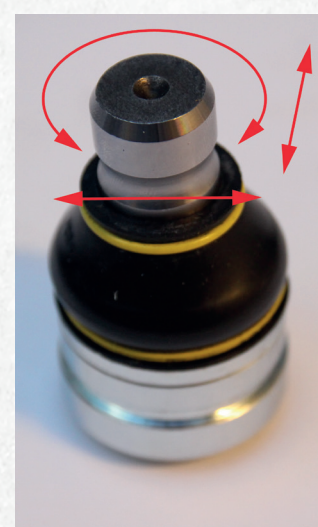
SEIZED BALL PIN

Appearance:
– Ball pin is very hard to move by hand (rotation torque >30-40 Nm) and/or has a jerk effect (high breakaway torque).
– No visible trace of damage, nor any contaminant intrusion on housing area.

Most probable causes:
– Product defect
– Oversized housing diameter of a pressed ball joint, seizing after being pressed on its arm body bore

Effect:
Potentially a safety-critical issue. A reduction of power steering efficiency is evident and in extreme cases the driver cannot recover steering to the neutral position after cornering.

How to fix it:
→ Replace the seized ball joint and/or full assembled control arm as applicable.

Prevention:
– Check the housing diameter of a pressed ball joint is compatible with arm body hole diameter
– Check, by hand for the correct articulation of the ball pin within its housing (Moog's advanced quality control only validates each assembly when the correct torque is achieved)

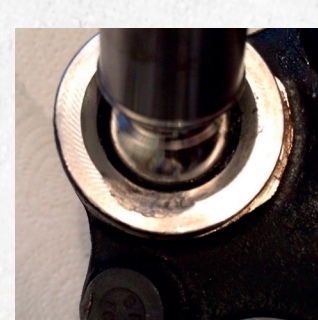
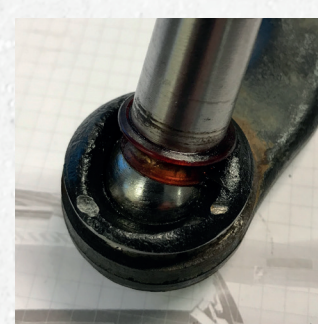
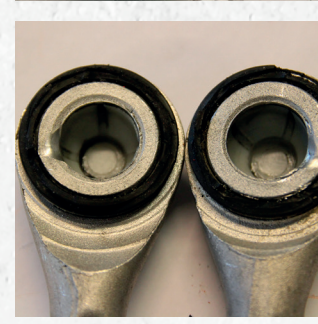
IMPACTS ON HOUSING FLANGES

Appearance:
Obvious traces of impact on the housing flange.

Most probable causes:
– Damage caused by hard driving or impact, especially at roundabouts (kerb, pothole, speed hump etc.)
– Insufficient ball pin articulation angle (each Moog ball joint is carefully designed to follow OE specifications to ensure the correct articulation angle for each vehicle application)
– Inversion L/R during installation (especially valid for link stabilizers where ball pins are shifted by 150°)

Effect:
Any high impact is likely to deform the plastic bearing through the reverberation of force on the ball pin. The result is a knocking noise due to development of excessive ball pin clearance.

How to fix it:
→ Such impact can potentially weaken other steering and suspension parts. As a safety measure, as well as replacing the damaged part, the full system should be checked.

Prevention:
– Avoid hard driving and impacts
– Double check that any handed part is fitted on the correct position

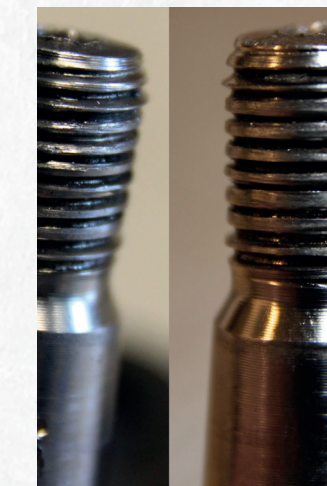
STUD, NUT OR BOLT DAMAGE

Appearance:
– Stud or bolt broken by torsion.
– Thread damaged.

Most probable causes:
– Product defect
– Incompatibility of thread size/pitch between bolt/stud and nut
– Incorrect tightening torque applied
– Wrong tooling used

Effect:
Safety critical risk. Compromised mechanical integrity.

How to fix it:
In the case of even the slightest suspicion of damage. Dismantle immediately and replace with new part.

Prevention:
– Use new and correctly specified fixings (Moog makes this easy by providing the required fitting accessories which meet the required specifications)
– Always tighten bolts/nuts using the vehicle manufacturer's recommended torque value
– Never use a torque gun or impact wrench. Use a standard manual torque wrench or other dedicated tool

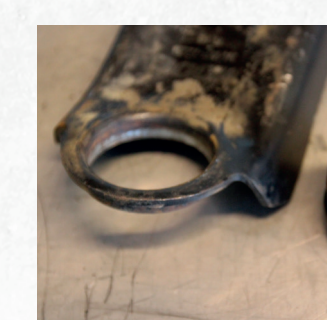
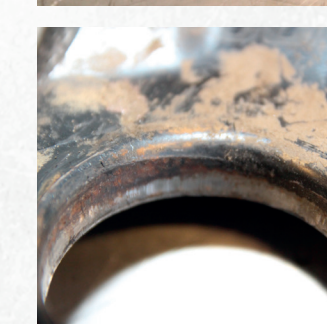
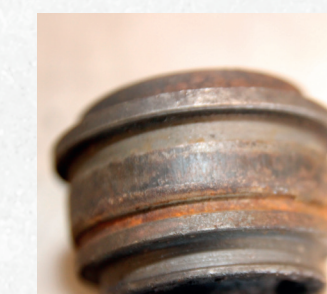
BALL JOINT LOOSE ON CONTROL ARM BODY

Appearance:
– Ball joint housing is turning loose within its arm body bore.
– Both ball joint housing and arm body bore flanges are rusty.

Most probable causes:
– Arm body bore flange not cleaned before pressing operation
– Incompatibility [housing - hole] diameters. Potentially multiple ball joint replacements have enlarged / ovalized the arm body hole
– Ball joint was not fully pressed or not pressed in straight

Effect:
Knocking noise. Progressive 'machining' of the arm body hole will cause a reduction of ball joint pull out force and the housing could 'pop out' of the arm body hole if not secured with a snap ring.

How to fix it:
→ No repair possible. Part must be replaced.

Prevention:
– Always press ball joints with dedicated equipment and appropriate tooling. (Moog servo-pressed and enhanced fixtures ensure a 100% conforming pressing operation)
– For driver safety, MOOG recommends that a 'press-in' ball joint is only replaced on one occasion and that any subsequent repair should use a fully assembled wishbone arm

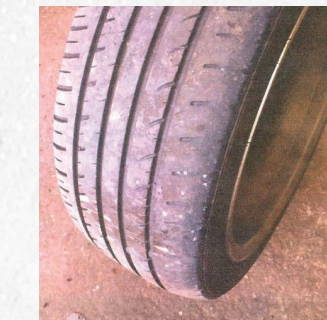
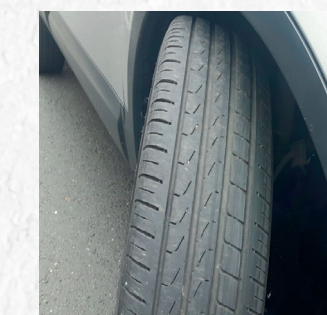
ABNORMAL TIRE WEAR

Appearance:
Tyres display abnormal or uneven wear from the outer to inner edges.

Most probable causes:
Wheels are not correctly aligned (particularly toe and camber alignment) after impact, a change of steering/suspension parts or for an extended period of time

Effect:
Vehicle may pull to one side or steering may be difficult or erratic.

How to fix it:
– Replace excessively worn tyres, as well as any potentially damaged part of the steering and suspension system
– Carry out a wheel alignment on the vehicle

Prevention:
Always carry out a wheel alignment:
– After an impact
– After any change of steering and suspension part
– At regular service intervals
