TECHNICAL TIPS

N°7: BRAKE RELATED VIBRATION

BRAKE JUDDER N°2

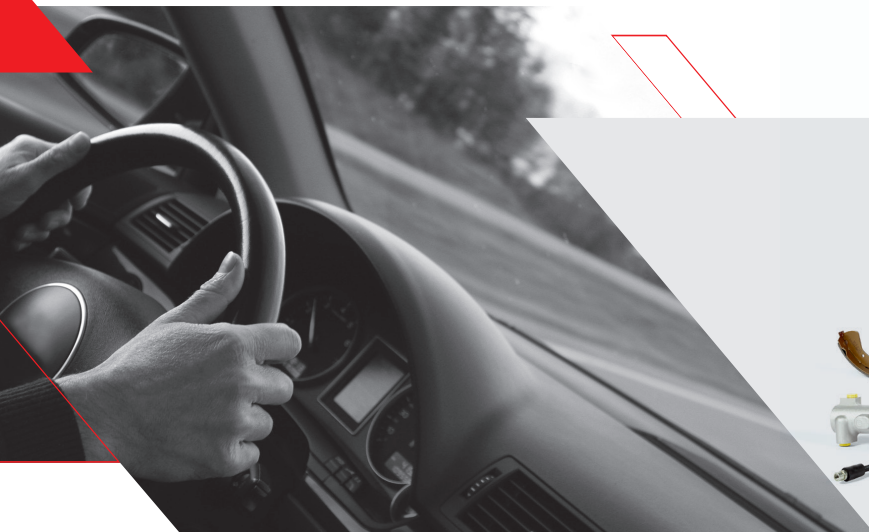
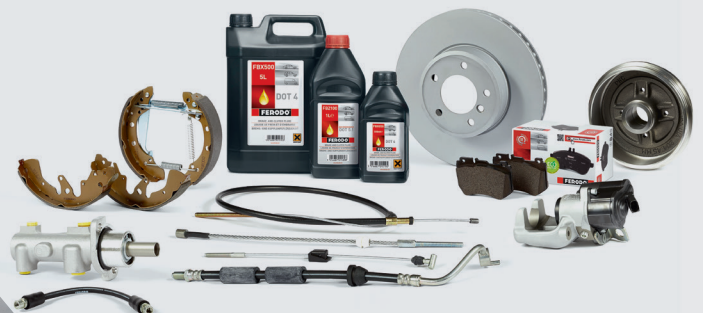
DTV is the variation in thickness around the disc surface. For effective braking, the disc should have the same thickness throughout. But DTV indicates unevenness on the friction surface of the disc. When you brake a vehicle with DTV on one or more of the wheels, the brake pad loses and regains contact with the disc(s) as it turns. And that's what causes brake judder.

Run-out error between the supporting and the braking surfaces.
