“Fixing Marks” on Phosphate Coated Pistons

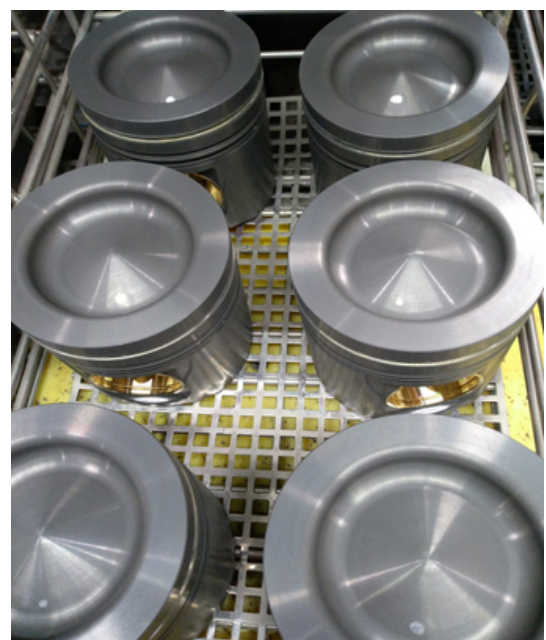
Picture 2:

Post-phosphate coating: Note the small bright circular uncoated “fixing marks” on the piston crowns.

“Fixing marks” / uncoated areas on the crowns of phosphate coated aluminium pistons are an effect of the phosphate coating process. They do not affect the piston operating properties, and the pistons are fully compliant with the acceptance specifications (Nüral TSIE-014-001).
