PIPE & RUBBER HANGER DEFECTS

WORN ENGINE MOUNTINGS & FLEXIBLE DRIVE SHAFT JOINT DEFECTS

SILENCER HOUSING & COVER DEFECTS

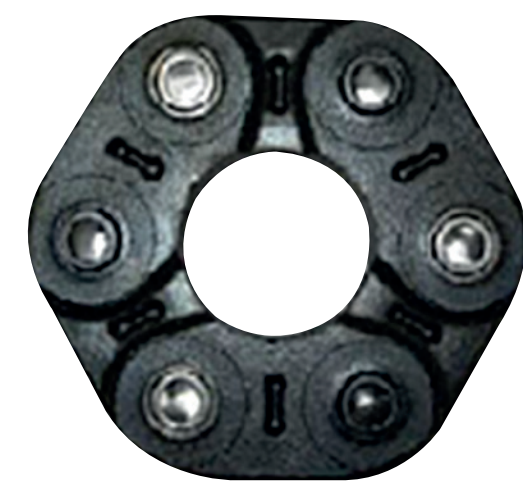
Worn-out or broken engine mountings or flexible drive shaft joints produce a typical irregularly shaped fracture which destroys the pipe a few centimetres behind the connection to the silencer.

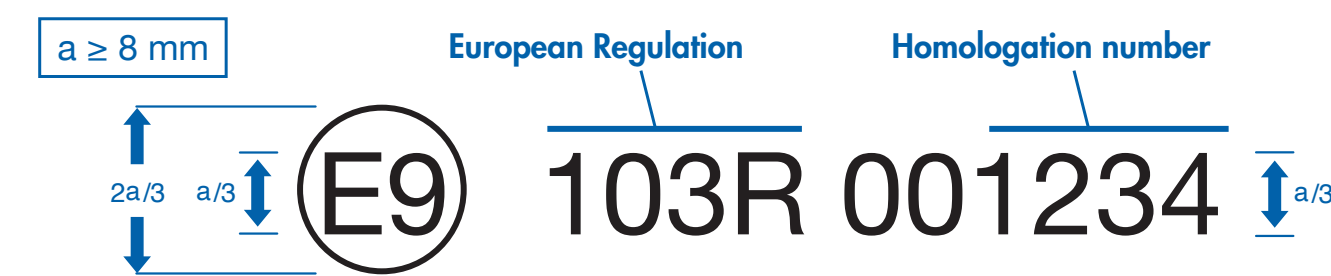
European Homologation code for Catalytic Converters

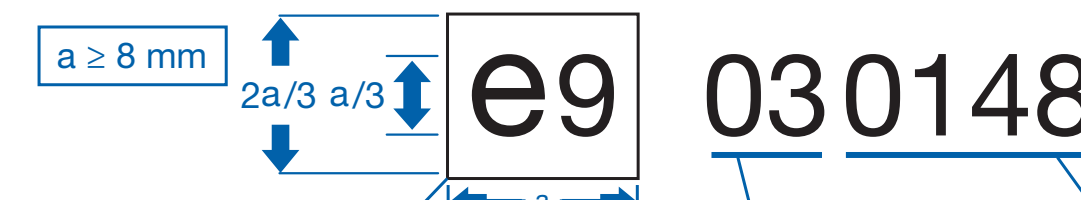
European Homologation code for Silencers

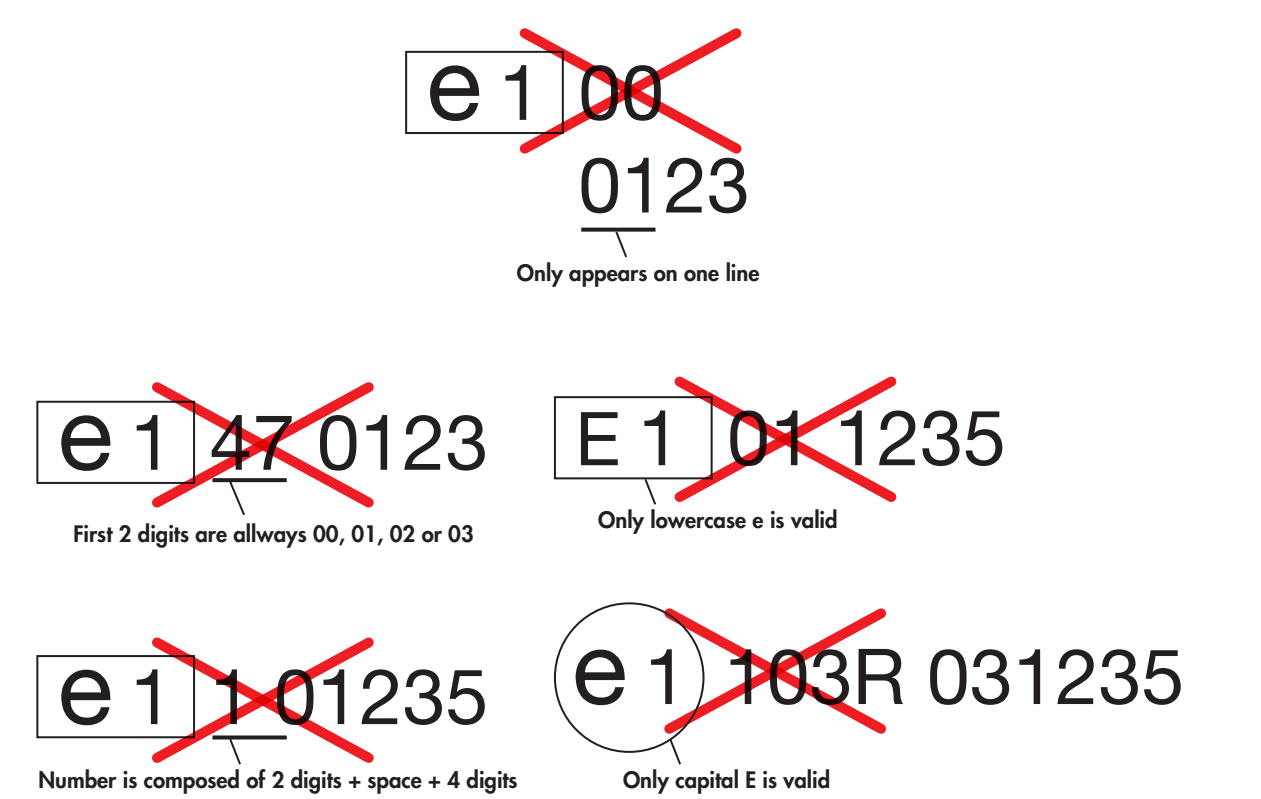
Examples of incorrect codes on products
