Fitting Wet Liners - The Importance of Cleanliness

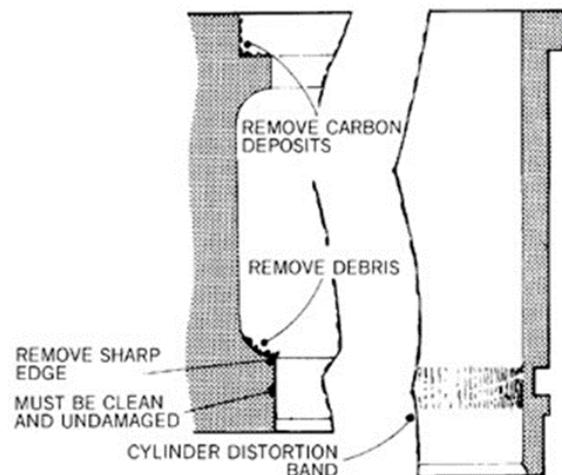
If dismantling a wet lined engine to investigate an operating problem shortly after reconditioning, examine the inside of each liner adjacent to the sealing ring grooves. Remove the liner if a band of wear, polishing or seizure is visible. Examine the sealing areas for any problem that could place pressure on the liner.

Ensure that the sealing area in the cylinder block is clean, undamaged and remove burrs or sharp edges that could damage the sealing rings. Also, ensure the rings are not twisted in their grooves. Lubricate them generously, with rubber grease if possible, and install the liner.

It is normal to feel slight resistance as the sealing rings compress into their grooves. If undue force is required, withdraw and investigate the cause of the resistance and correct. Do not use excessive force.
