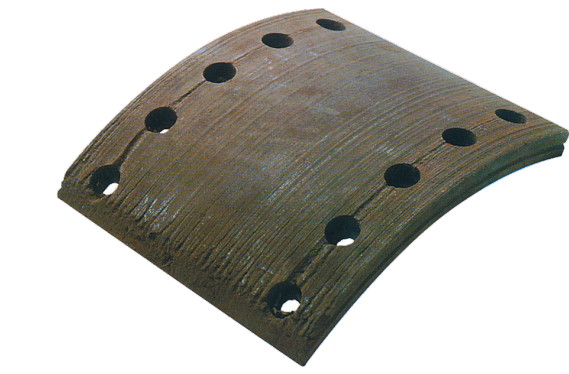
DEEP IRREGULAR CIRCUM-FERENTIAL GROOVES

- MAIN REASONS**
- Large particles loose in the brake
 - Very poor drum condition and maintenance
- POSSIBLE EFFECTS**
- Very high lining and drum wear
 - Squeal
- SOLUTION** Avoid contamination. Replace linings and grind or replace drum as appropriate.

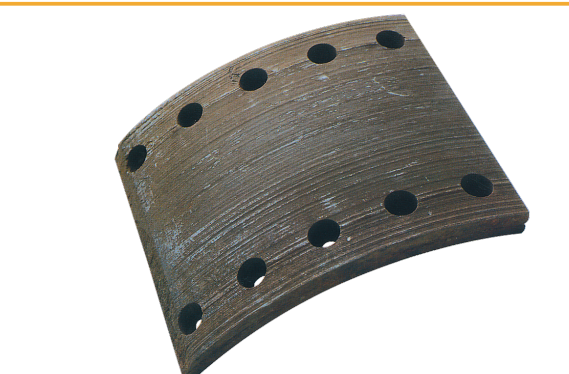
GROOVED LINING SURFACE

- MAIN REASONS**
- Small loose particles in the brake
 - Insufficient drum cleaning at replacement
- POSSIBLE EFFECTS**
- Very high lining and drum wear
 - Squeal
- SOLUTION** Replace linings and avoid brake operation in dusty environment. Grind or replace drum as appropriate

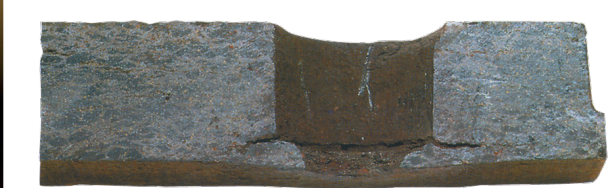
CRACKS AROUND RIVET HOLES

- MAIN REASONS**
- Too heavy riveting force
 - Wrong shape of rivet heads
 - Brake shoe radius does not conform to lining radius
 - Brake shoe platform is not clean or even
- POSSIBLE EFFECTS**
- Lining and drum breakage
 - Brake over-heating
 - Noise
- SOLUTION** Replace linings, and avoid excessive pressure during riveting operations

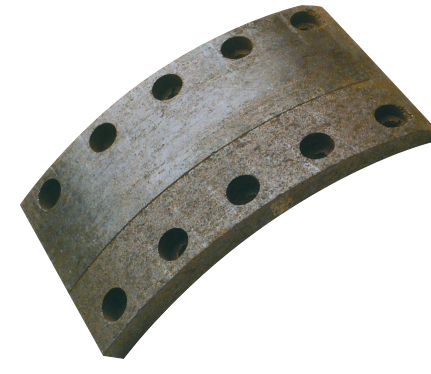
STEPS IN THE LINING SURFACE

- MAIN REASONS**
- There may be a step in the brake drum surface
 - General drum wear
- POSSIBLE EFFECTS**
- Rapid lining wear
 - If the wear pattern differs across the axle, vehicle pull and excessive noise can result
- SOLUTION** Grind/Machine drum surface or renew (a drum grind may incur oversize lining fitment)

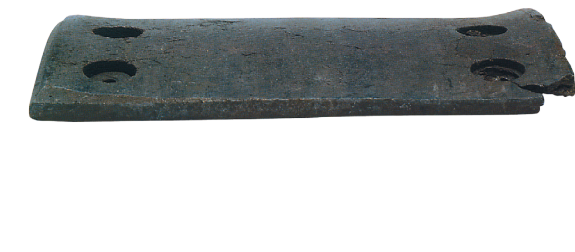
UNEVEN LINING SURFACE

- MAIN REASONS**
- Wrongly adjusted or worn axle bearings
- POSSIBLE EFFECTS**
- Very high lining and drum wear
 - Squeal
- SOLUTION** Replace linings, replace wheel bearing and replace or grind drum as appropriate

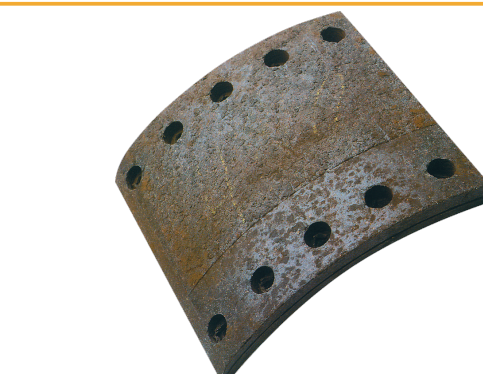
SCARRED LINING SURFACE

- MAIN REASONS**
- Poor drum condition, e.g. heat crazing
- POSSIBLE EFFECTS**
- Rapid lining wear
 - If linings not 100% bedded-in, low brake efficiency can result
- SOLUTION** Replace linings and avoid overheating brakes

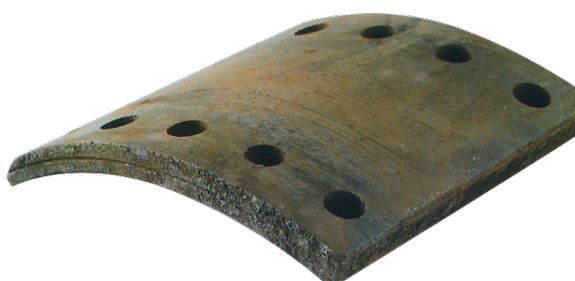
GREASY LINING SURFACE

- MAIN REASONS**
- Broken or improperly mounted hub oil seals
 - Excessive lubrication of the bearings of the braking mechanism
- POSSIBLE EFFECTS**
- Vehicle pull may occur if the problem is only found at one side of the axle
 - Low deceleration
- SOLUTION** Remove grease from the linings, cure oil/grease leaks

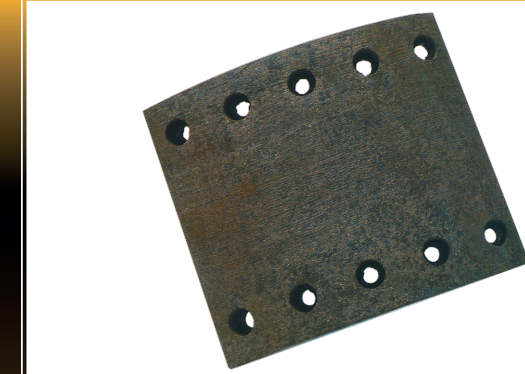
CIRCUM-FERENTIAL GROOVES

- MAIN REASONS**
- Poor drum condition
 - Improper preparation with a wire brush, shoe grinder or similar
- POSSIBLE EFFECTS**
- Vehicle pull may occur if there is a different wear pattern on the opposite axle end
 - Insufficient deceleration and excessive noise
- SOLUTION** Replace linings and grind or replace drum as appropriate

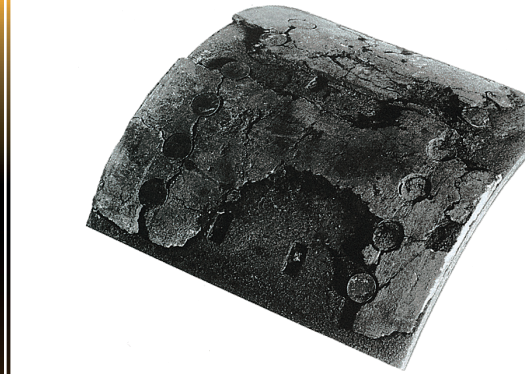
LARGE FRACTURES IN LINING SURFACE

- MAIN REASONS**
- Faults in brake mechanism
 - Sticking brake shoes (weak return springs)
 - Excessive use of brakes at high speed
 - Overloaded vehicle
 - Too large air chambers
- POSSIBLE EFFECTS**
- High lining wear
 - Vehicle pull and excessive brake noise
 - Disintegration of lining
 - Low deceleration
- SOLUTION** Replace linings, avoid overworking brakes and ensure brake components are correct and are in good condition

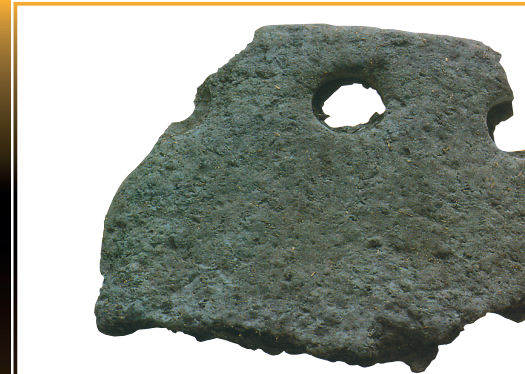
BURNT LINING SURFACE

- MAIN REASONS**
- Faults in brake mechanism
 - Sticking brake shoes (weak return springs)
 - Excessive use of brakes from high speed
 - Wrong brake cylinders/air chambers or levers
 - Overloaded vehicle
 - Incorrect brake proportioning between tractor/trailer units
- POSSIBLE EFFECTS**
- High lining wear
 - Vehicle pull and excessive brake noise
 - Deceleration too low
- SOLUTION** Replace linings, avoid overworking brakes and ensure brake components are correct and are in good condition

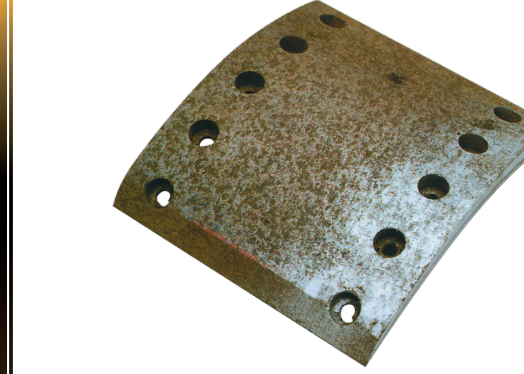
DIRT ON THE LINING SURFACE

- MAIN REASONS**
- Dirt particles in the brake
 - Poor brake maintenance (insufficient cleaning)
- POSSIBLE EFFECTS**
- High lining and drum wear
 - Poor deceleration
 - Vehicle pull and excessive brake noise may occur
- SOLUTION** If heavy contamination, replace linings and ensure contamination-free relining operation

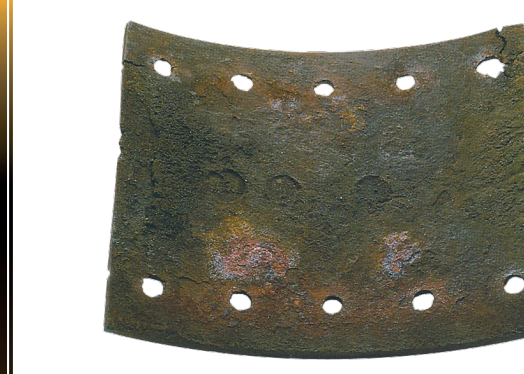
BUILD UP OF DIRT BETWEEN LINING AND BRAKE SHOE

- MAIN REASONS**
- Shoe radius out of line
 - Shoe platform not blast cleaned and painted properly
 - Shoe platform not parallel
 - Lining riveted incorrectly
- POSSIBLE EFFECTS**
- Cracks in the lining material or crack in drum surface
 - Loose linings
 - Squeal
 - Improper cleaning causes rust scale to build up and lift the lining from the shoe
- SOLUTION** Replace linings and ensure shoe is clean and free from contamination before lining fitment

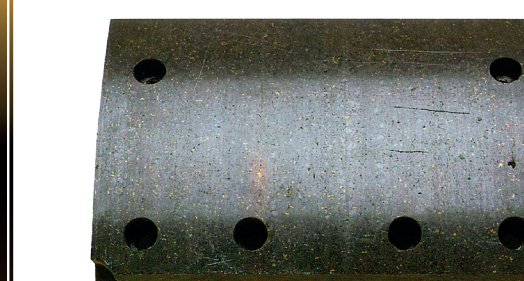
SURFACE CRAZING

- MAIN REASONS**
- Caused by excessive brake temperature, i.e. when brake is cold on motorway then having to perform a sudden stop i.e. off a slip road. Rapid temperature input does not allow for heat soak from material into brake system
- POSSIBLE EFFECTS**
- This condition has no effect on the integrity or performance of the lining
 - Penetration of the crazing is usually no more than 1mm deep
 - Wear through with normal brake use and has no effect on the lining
- SOLUTION** Avoid high-speed heavy duty braking from cold

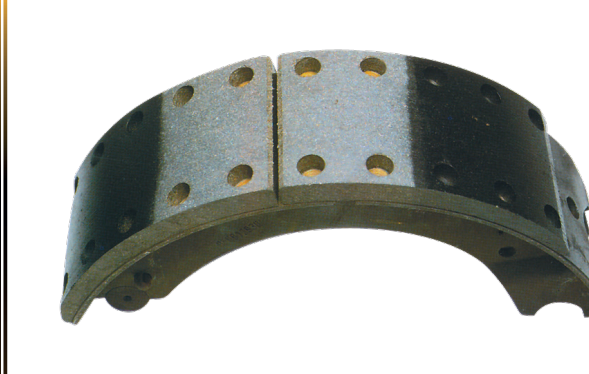
POOR BEDDING-IN 1

- MAIN REASONS**
- Lining radius is larger than actual drum diameter
 - Bedding-in period for the lining was too short
- POSSIBLE EFFECTS**
- Vehicle pull and excessive brake noise may occur
 - Low deceleration
- SOLUTION** Replace linings and ensure the correct lining radius to drum diameter is selected, or extend bedding-in period

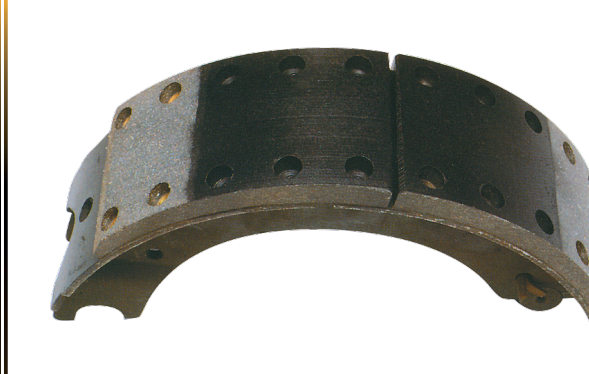
POOR BEDDING-IN 2

- MAIN REASONS**
- Drum diameter is larger than lining radius
 - Bedding-in period for the lining was too short
 - Drum wear
- POSSIBLE EFFECTS**
- If the wear pattern differs across the axle, vehicle pull can result; also excessive brake noise
 - Low deceleration
- SOLUTION** Replace linings and ensure the correct lining radius to drum diameter is selected, or extend bedding-in period

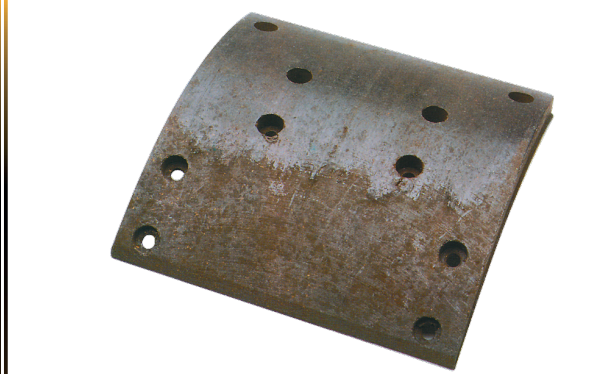
POOR BEDDING-IN 3

- MAIN REASONS**
- Bedding-in period for the lining was too short
 - Drum wear
- POSSIBLE EFFECTS**
- Either low or very high deceleration, with high deceleration the linings may lock on to the drum
 - If the wear pattern differs across the axle, vehicle pull and excessive noise can result
- SOLUTION** Replace linings and ensure the correct lining radius to drum diameter is selected, or extend bedding-in period
