TROUBLE TRACER – BRAKE DISCS

INCORRECT ASSEMBLY

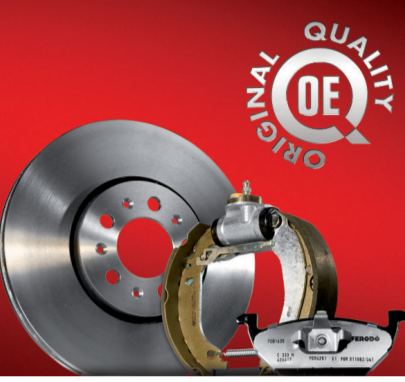
APPEARANCE Hub contact surface is detached or distorted

CAUSE Excessive tightening and failure to observe manufacturer's recommended torque and sequence during tightening

EFFECT Detachment of disc contact surface. Complete brake failure

REMEDY Full inspection of braking system and associated components. Replace any failed components and fit new discs observing manufacturer's recommended torque and sequence during tightening
