TROUBLE TRACER – LININGS

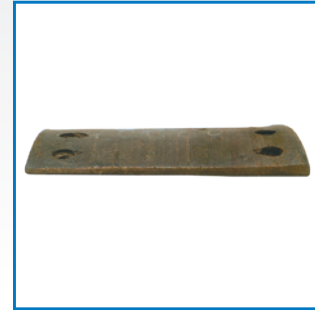
LINING SURFACE TAPERED

MAIN REASONS

- Brake shoes misaligned with the brake drum
- Distorted brake shoe or brake drum turned on taper

POSSIBLE • The linings may lock on to the drum when braking from high speeds
EFFECTS • Vehicle pull and excessive brake noise may occur

SOLUTION Replace or grind/machine drum. Replace brake shoe anchor pins or parts that locate brake shoes

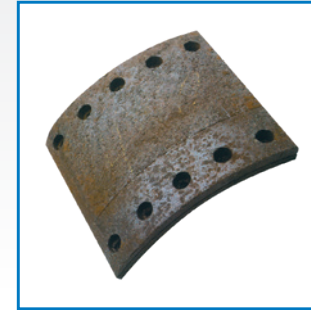
SCARRED LINING SURFACE

MAIN REASONS • Poor drum condition, e.g. heat crazing

POSSIBLE • Rapid lining wear
EFFECTS • If linings not 100% bedded-in, low brake efficiency can result

SOLUTION Replace linings and avoid overheating brakes

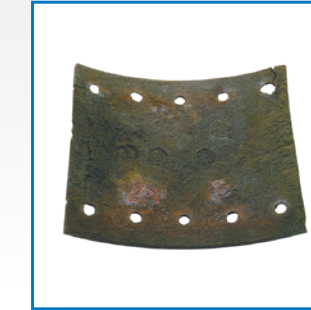
BUILD UP OF DIRT BETWEEN LINING AND BRAKE SHOE

MAIN REASONS

- Shoe radius out of line
- Shoe platform not blast cleaned and painted properly
- Shoe platform not parallel
- Lining riveted incorrectly

POSSIBLE • Cracks in the lining material or crack in drum surface
EFFECTS • Loose linings

• Squeal
 • Improper cleaning causes rust scale to build up and lift the lining from the shoe

SOLUTION Replace linings and ensure shoe is clean and free from contamination before lining fitment

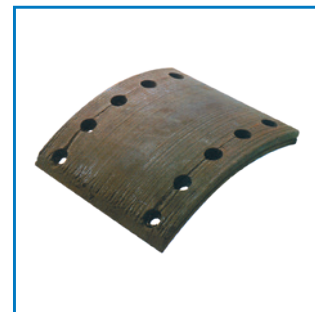
DEEP IRREGULAR CIRCUMFERENTIAL GROOVES

MAIN REASONS

- Large particles loose in the brake
- Very poor drum condition and maintenance

POSSIBLE • Very high lining and drum wear
EFFECTS • Squeal

SOLUTION Avoid contamination. Replace linings and grind or replace drum as appropriate

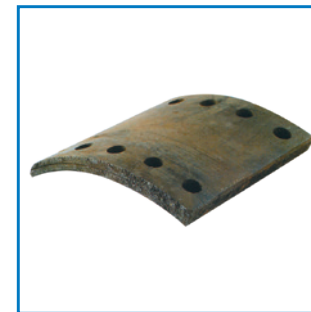
GREASY LINING SURFACE

MAIN REASONS

- Broken or improperly mounted hub oil seals
- Excessive lubrication of the bearings of the braking mechanism

POSSIBLE • Vehicle pull may occur if the problem is only found at one side of the axle
EFFECTS • Low deceleration

SOLUTION Remove grease from the linings, cure oil/grease leaks

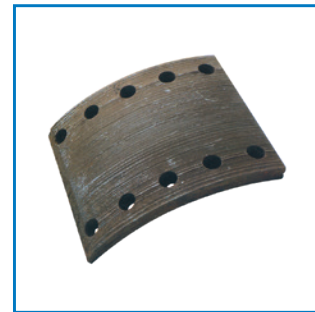
GROOVED LINING SURFACE

MAIN REASONS

- Small loose particles in the brake
- Insufficient drum cleaning at replacement

POSSIBLE • Very high lining and drum wear
EFFECTS • Squeal

SOLUTION Replace linings and avoid brake operation in dusty environment. Grind or replace drum as appropriate

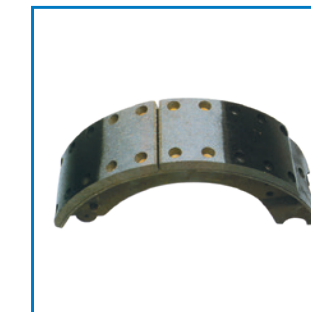
POOR BEDDING-IN 1

MAIN REASONS

- Lining radius is larger than actual drum diameter
- Bedding-in period for the lining was too short

POSSIBLE • Vehicle pull and excessive brake noise may occur
EFFECTS • Low deceleration

SOLUTION Replace linings and ensure the correct lining radius to drum diameter is selected, or extend bedding-in period

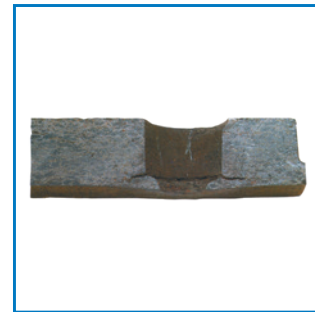
CRACKS AROUND RIVET HOLES

MAIN REASONS

- Too heavy riveting force
- Wrong shape of rivet heads
- Brake shoe radius does not conform to lining radius
- Brake shoe platform is not clean or even

POSSIBLE • Lining and drum breakage
EFFECTS • Brake over-heating
 • Noise

SOLUTION Replace linings, and avoid excessive pressure during riveting operations

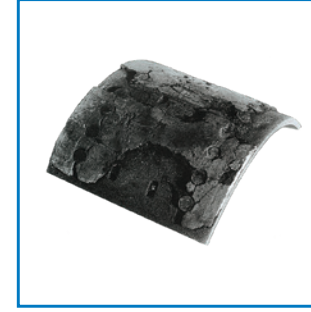
LARGE FRACTURES IN LINING SURFACE

MAIN REASONS

- Faults in brake mechanism
- Sticking brake shoes (weak return springs)
- Excessive use of brakes at high speed
- Overloaded vehicle
- Too large air chambers

POSSIBLE • High lining wear
EFFECTS • Vehicle pull and excessive brake noise
 • Disintegration of lining
 • Low deceleration

SOLUTION Replace linings, avoid overworking brakes and ensure brake components are correct and are in good condition

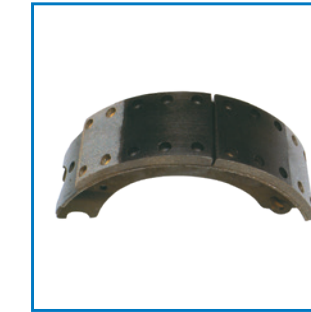
POOR BEDDING-IN 2

MAIN REASONS

- Drum diameter is larger than lining radius
- Bedding-in period for the lining was too short
- Drum wear

POSSIBLE • If the wear pattern differs across the axle, vehicle pull can result; also excessive brake noise
EFFECTS • Low deceleration

SOLUTION Replace linings and ensure the correct lining radius to drum diameter is selected, or extend bedding-in period

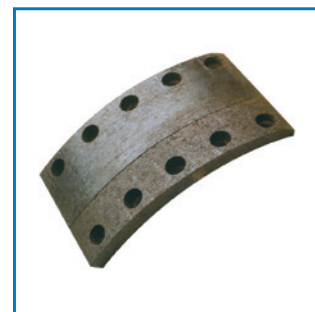
STEPS IN THE LINING SURFACE

MAIN REASONS

- There may be a step in the brake drum surface
- General drum wear

POSSIBLE • Rapid lining wear
EFFECTS • If the wear pattern differs across the axle, vehicle pull and excessive noise can result

SOLUTION Grind/Machine drum surface or renew (a drum grind may incur oversize lining fitment)

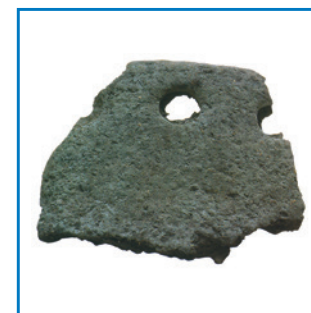
BURNT LINING SURFACE

MAIN REASONS

- Faults in brake mechanism
- Sticking brake shoes (weak return springs)
- Excessive use of brakes from high speed
- Wrong brake cylinders/air chambers or levers
- Overloaded vehicle
- Incorrect brake proportioning between tractor/trailer units

POSSIBLE • High lining wear
EFFECTS • Vehicle pull and excessive brake noise
 • Deceleration too low

SOLUTION Replace linings, avoid overworking brakes and ensure brake components are correct and are in good condition

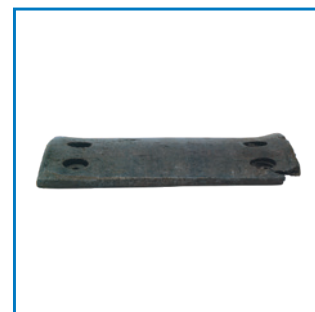
UNEVEN LINING SURFACE

MAIN REASONS • Wrongly adjusted or worn axle bearings

POSSIBLE • Very high lining and drum wear
EFFECTS • Squeal

SOLUTION Replace linings, replace wheel bearing and replace or grind drum as appropriate
