TECHNICAL TIPS

N°1: HOT RUNNING AIR DISC SYSTEMS

BRAKE ADJUSTMENT: RUNNING CLEARANCE

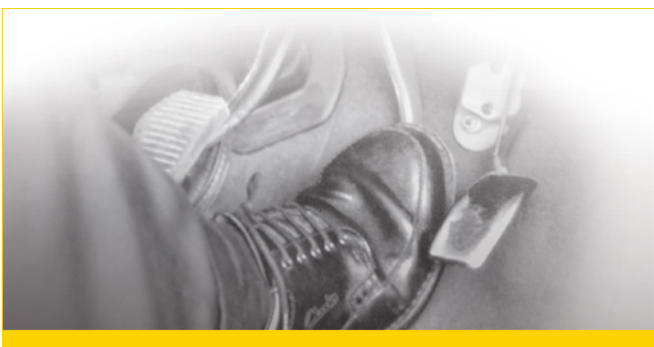
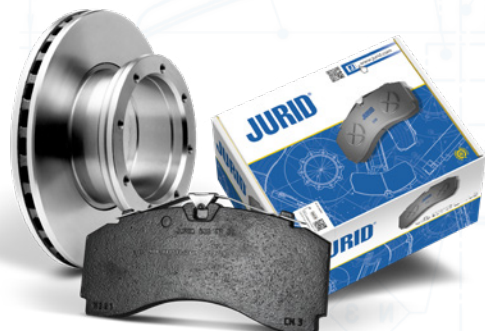
- Ensure the brakes are disengaged, and that the vehicle is blocked to ensure it does not roll.
- Remove the wheel.
- Press the caliper assembly inboard on its guide pins. Press the inboard pad away from the tappets and check both the tappets and the inboard pad back-plate.

- Check the running clearance with a feeler gauge between tappets and inboard pad back-plate, and it should be in the range described in the table below.

- If the running clearance is smaller or higher than the correct value shown in the table below continue the procedure as follows.
- Set the running clearance at 2mm.

- Apply the brakes 50 times.
- Check the running clearance again with a feeler gauge, and it should be in the range described in the table below.
- If the running clearance is still smaller or higher than the correct value shown in the table below, either the entire brake or the housing only will need to be fully replaced according to the brake manufacturer's manuals.
