CV TROUBLE TRACER - BRAKE PADS AND DISCS

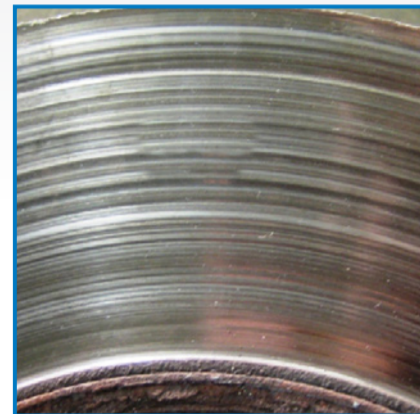
APPEARANCE Disc featuring scored surface

CAUSE Pads fitted with friction material too harsh for the disc or new pads assembled on excessively worn out discs

EFFECT Reduction in braking performance and possible imbalance on the affected axle during braking

- REMEDY**
- Replace the pads
 - Check disc condition and minimum thickness.
 - If necessary, replace the disc
 - Check for the quality of the spare parts used

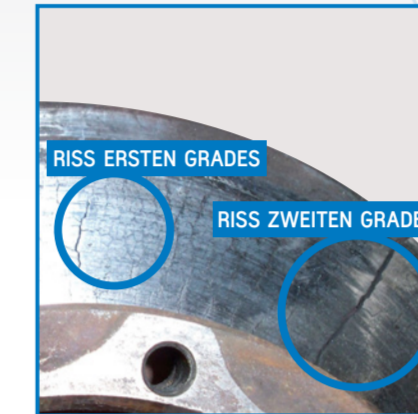
APPEARANCE Disc surface features 1st and 2nd degree crack

CAUSE Too intensive use of brakes due to the track features or to the carried load

EFFECT Possible unexpected disc mechanical collapse, particularly with 2nd degree crack

- REMEDY**
- Compulsory replacement of brake discs and pads particularly with 2nd degree crack, when one of the cracks is travelling from OD to ID
 - Brake calipers shall be checked

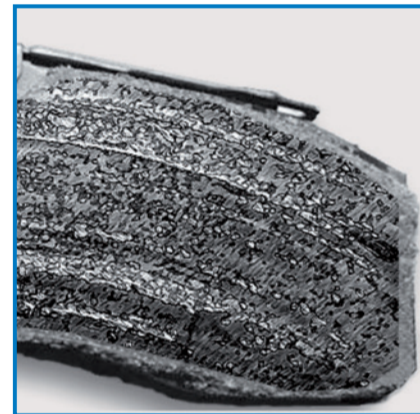
APPEARANCE Contaminated pad friction material

CAUSE Contamination by an oily substance or solvent

EFFECT Reduction in braking performance and possible imbalance during braking

- REMEDY**
- Replace the pads
 - Check the discs on the axle
 - Identify any fluid leaks from the hubs or other nearby components

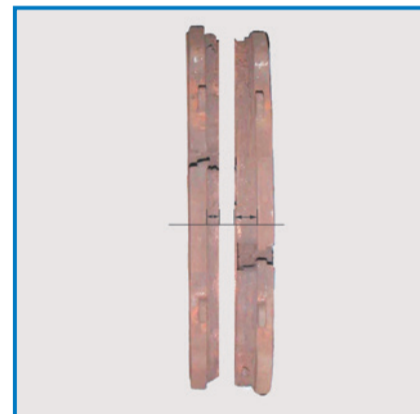
APPEARANCE Uneven brake pad wear

CAUSE One of the calipers has become stuck or does not return correctly to the rest position

EFFECT Reduction in braking performance and possible imbalance on the involved axle, during braking

- REMEDY**
- Replace the pads
 - Brake calipers should be checked

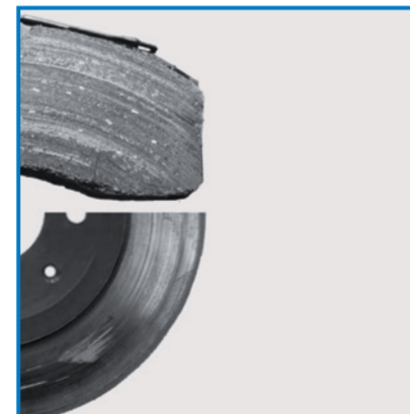
APPEARANCE Friction includes metal pick-up

CAUSE High temperature generated between brake pad and disc in wet conditions

EFFECT Wear of the affected brake disc with typical metal rubbing noise during braking

- REMEDY**
- Replace the pads
 - Check disc condition and minimum thickness
 - If necessary, replace both discs on the axle

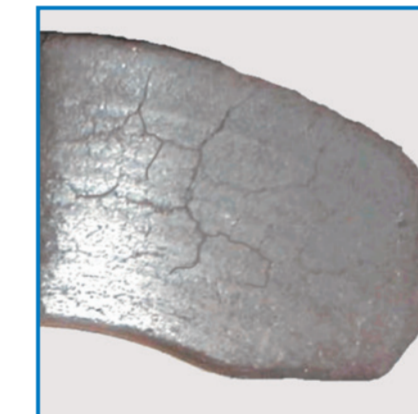
APPEARANCE Pad with surface cracks

CAUSE Excessive load or high friction material temperature

EFFECT Possible detachment of friction material resulting in a reduction in braking performance

- REMEDY**
- Replace the pads
 - Check for correct caliper operation
 - Check disc condition and minimum thickness
 - If necessary, replace both discs on the axle

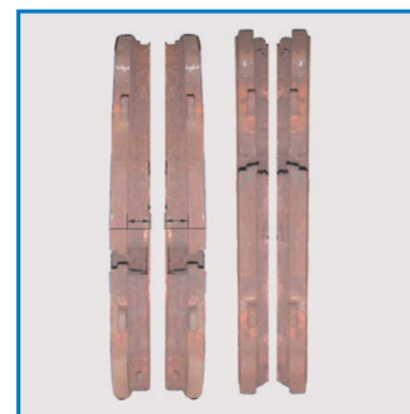
APPEARANCE Pads on the same axle featuring uneven wear

CAUSE Incorrect return of one caliper on the same axle

EFFECT If the axle involved is the directional one, this fault may result in vehicle instability during brake release

- REMEDY**
- Replace the pads
 - Check for the proper caliper operation
 - Check disc condition and minimum thickness
 - If necessary, replace both discs on the axle
