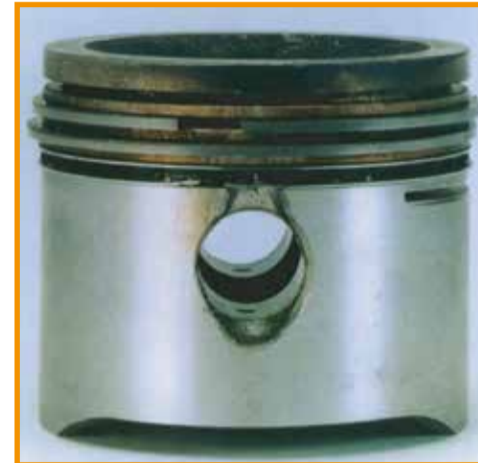
Erosion of piston skirt adjacent to piston pin hole. The material sometimes appears to have melted Damage to cylinder bore.

Symptom: Engine noise. Oil consumption.
Cause: Foreign matter assembled with piston, in pin bore. Used circlips refitted. Incorrect fitting of circlips. End thrust transmitted via the piston pin from misaligned connecting rod or crankshaft end float.
Remedy: Correct any cylinder bore damage. Check for and correct any connecting rod or small end bush misalignment. Check and correct any connecting rod misalignment or excessive crankshaft end float. Replace piston assembly ensuring that the circlips are correctly located.

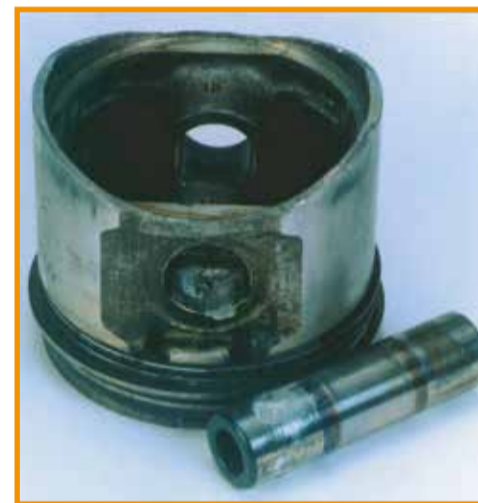
Piston pin seizure

Symptom: Engine noise.
Cause: Lack of clearance between rod bushing and pin. Lack of lubrication between piston pin and pin bore during installation.
Remedy: Replace damaged components. Ensure that the piston pin has the correct clearance in the small end, or if the pin is anchored in the connecting rod, ensure that the piston is free to articulate about the piston pin. Ensure adequate lubrication of piston and pin, especially during installation. Avoid lengthy periods of low engine speed during the running in period. Ensure any piston under crown cooling jets are functioning correctly.

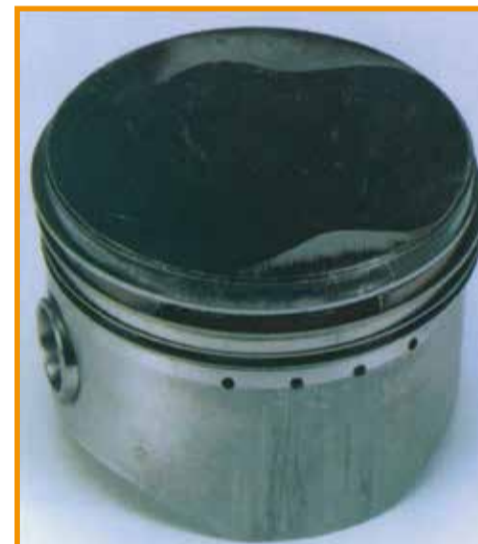
Fracture of piston ring land
 (Note fracture angle)

Symptom: Oil consumption, loss of power.
Cause: Incorrect fuel usage. Oil in combustion chamber. Excessively high compression ratio. Ignition timing too advanced. Intake air temperatures too high.
Remedy: Establish cause, and correct. Replace damaged components.

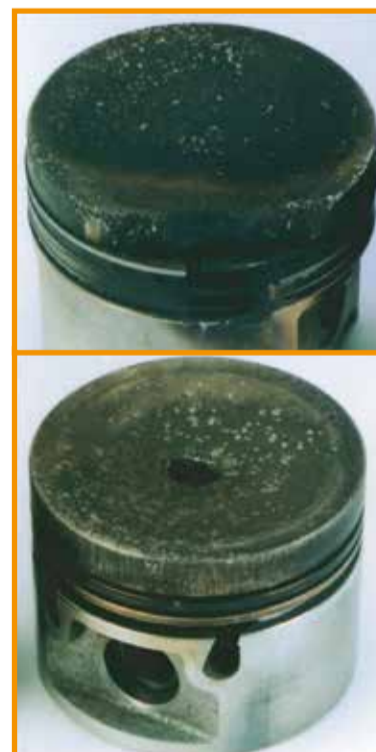
Hole in piston crown. Crown edge burning.

Symptom: Engine noise: Pinging/loss of power.
Cause: Heat range of spark plugs too low. Mixture too lean. Damaged/leaking valves, or insufficient valve clearance. Unsuitable fuel. General overheating.
Remedy: Check spark plugs and ignition setting. Ensure correct carburation/fuel injection. Ensure that no air leaks exist in the induction system. Use only correct fuel as specified by the engine manufacturer. Clear engine of debris & check valves and bearings for damage. Replace all damaged components.

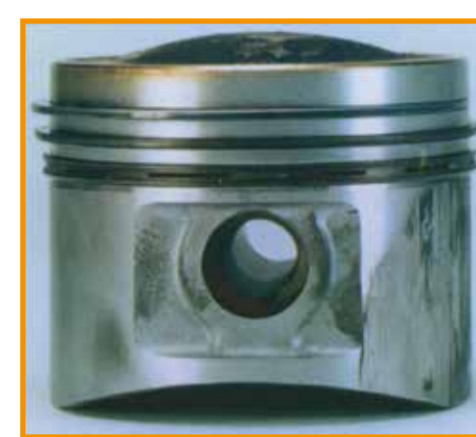
Seizure or scuffing of piston skirt thrust face (Non-thrust face remains relatively undamaged)

Symptom: Engine noise. Some power loss.
Cause: Oil starvation, possibly during initial use.
Remedy: Check the lubrication system and the cylinder bore and correct as necessary. Replace damaged components. Ensure the complete engine lubrication system is fully primed (oil pump, filter, etc.) before starting engine.

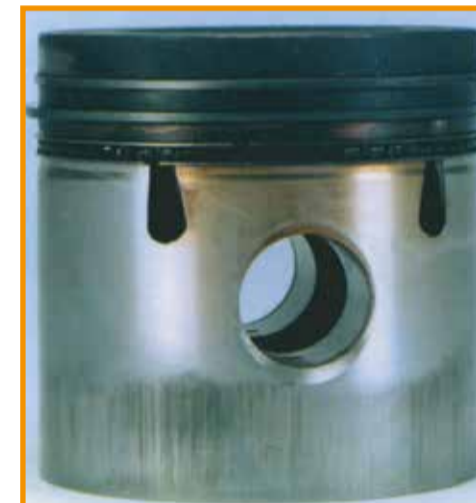
Piston seizure. Skirt contact areas may appear smooth and polished.

Symptom: Engine does not develop normal full power. Engine may overheat.
Cause: Insufficient piston skirt to cylinder running clearance.
Remedy: Check cylinder bore size and correct if necessary. Ensure efficiency of engine cooling system. Replace damaged components and correct any damage to cylinder bore. Replace piston.

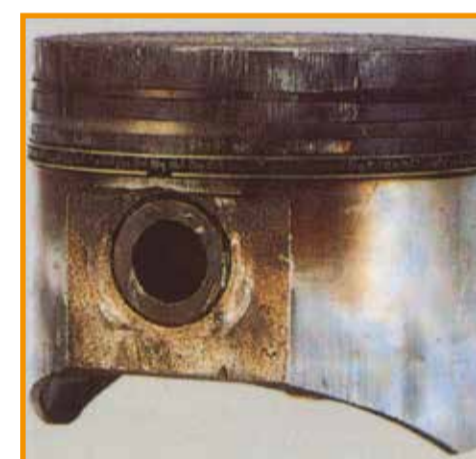
Piston rings trapped in their grooves.
 Rapid wear of piston ring outer surface.

Symptom: Oil consumption. Loss of power. Possible piston seizure.
Cause: High combustion temperature.
Remedy: Ensure ignition settings and spark plugs are correct. Ensure that the induction system is free of air leaks, and that the fuel to air mixture is correct. Replace damaged components.

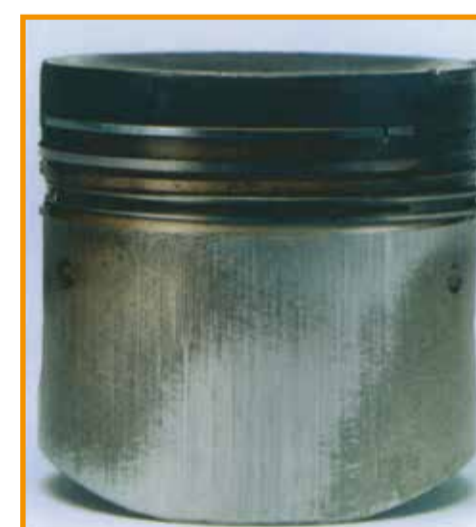
Incorrect (diagonal) skirt contact

Symptom: Oil consumption.
Cause: Bent connecting rod or misaligned small end bush. Excessive crankshaft end float. Liners not installed straight.
Remedy: Check connecting rod, also small end for any misalignment. Check crankshaft end float. Correct as necessary. New piston rings should be fitted.

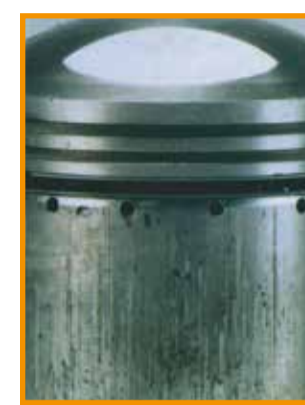
Vertical scratching or scuffing of piston skirt. Piston rings and cylinder bore may also be damaged by vertical scratching

Symptom: Oil consumption.
Cause: Abrasive matter in engine.
Remedy: Clean and inspect all engine components. Clean all oil-ways. Ensure that air and oil filters are clean and fitted with correct filter elements. Check the integrity of all connections between the air filter and engine. All damaged components should be replaced.

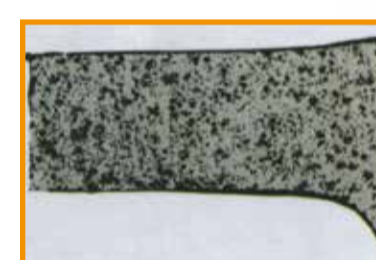
Accelerated side face wear of top compression rings (Other rings may be affected to a lesser degree)

Symptom: Oil consumption. Loss of power.
Cause: Liquid fuel degrading lubricant in ring grooves.
Remedy: Ensure that fuel mixture is correct, check fuel injection /ecu settings/choke, the air filter is not blocked or choked and that whenever possible the engine, once started from cold, attains full working temperature before being switched off, thus preventing fuel condensing in the cylinders. Do not "Pump" the throttle when the carburettor is fitted with an accelerator pump.
 If all rings in any cylinder are affected, check the cylinder honing pattern. Asymmetric or skewed honing may cause rings to rotate rapidly, and accelerate wear.
